APW100 Water-Based Corrosion Protection

# PRODUCT SHEET

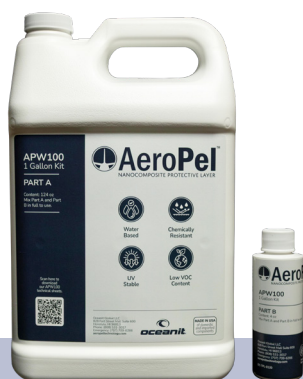
NPL water repellency

- **Advanced “Nanocomposite Protective Layer” (NPL):** A water-based, high-performance coating designed to deliver durable, long-term corrosion protection.
- **Comprehensive protection:** Shields aircraft exteriors, airframe structures, and internal components from corrosion damage.
- **Versatile application:** Can be applied over primers, as a finishing layer over topcoats, or directly onto conversion-coated or bare metals.
- **Performance-driven design:** Repels moisture (omniphobic), reduces fluid buildup, and lowers surface friction for long-lasting effectiveness.
